**The Causes and Remedial Measures of Cracks on Building Foundation  
on Expansive Soil Area Found at Koye-Feche Projects**

**A Project Submitted to the School of Graduate Studies of Addis Ababa  
Science & Technology University In Partial Fulfillment of the  
Requirements for the Degree of Master of Engineering in Geo-Technical  
Engineering.**

**June, 2017**

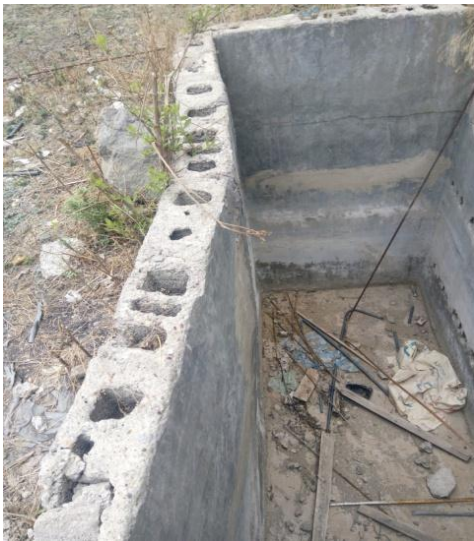
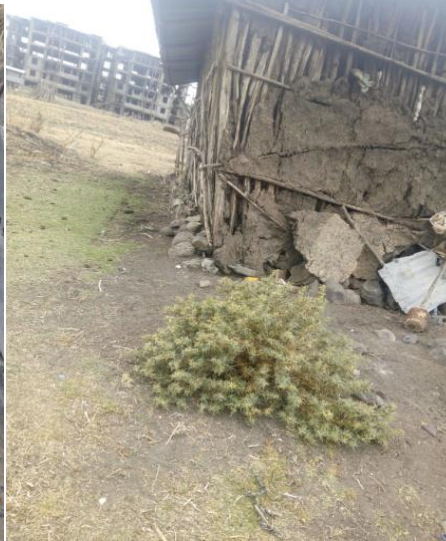
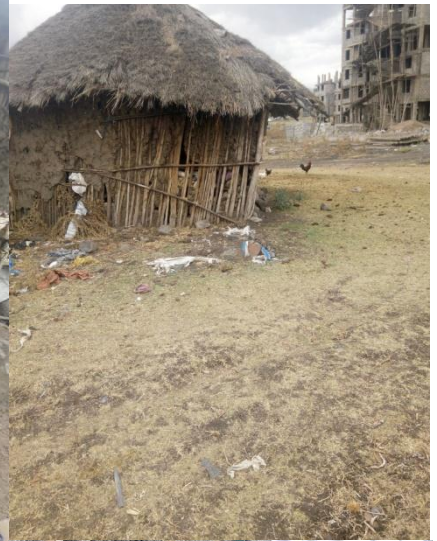
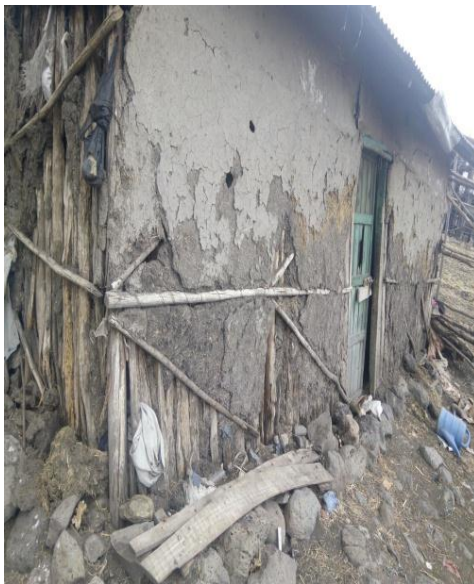
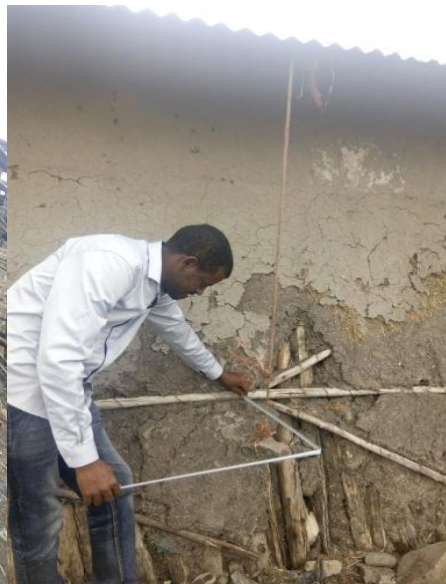
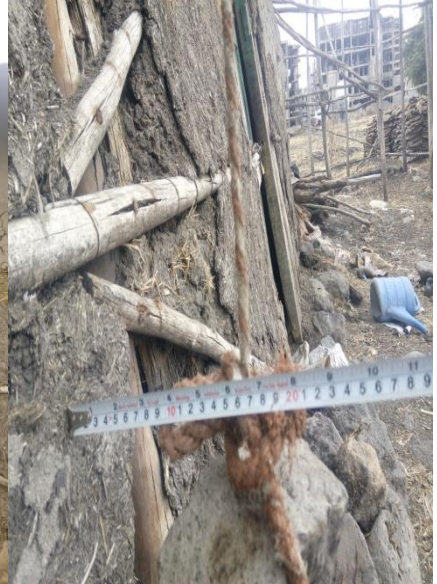
Sample pictures on damage of walls on agrostone, mud house and reservoir tanker.

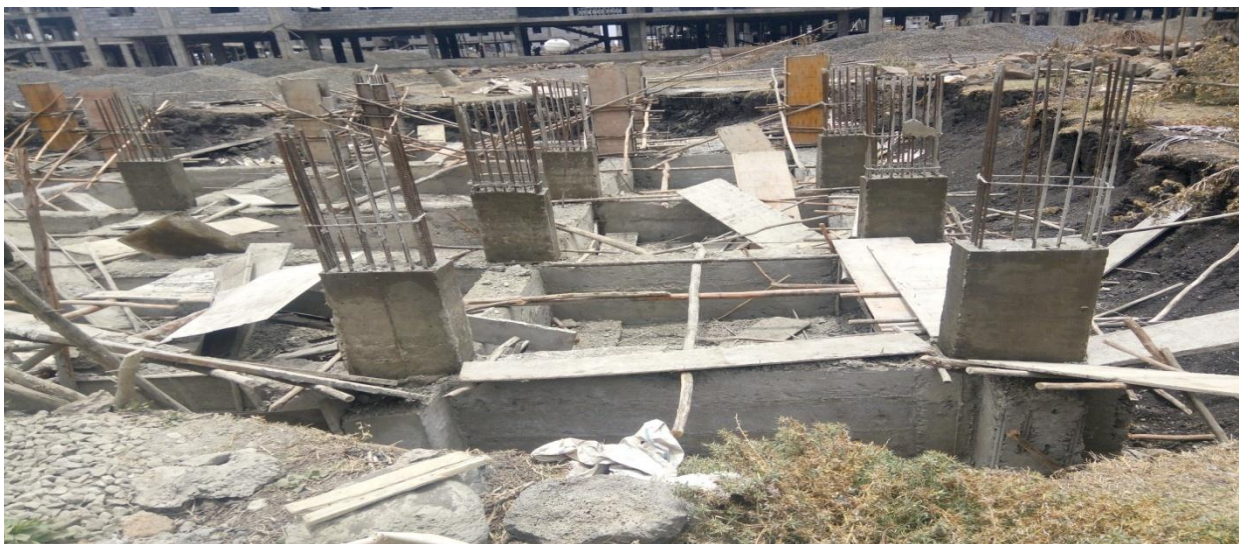
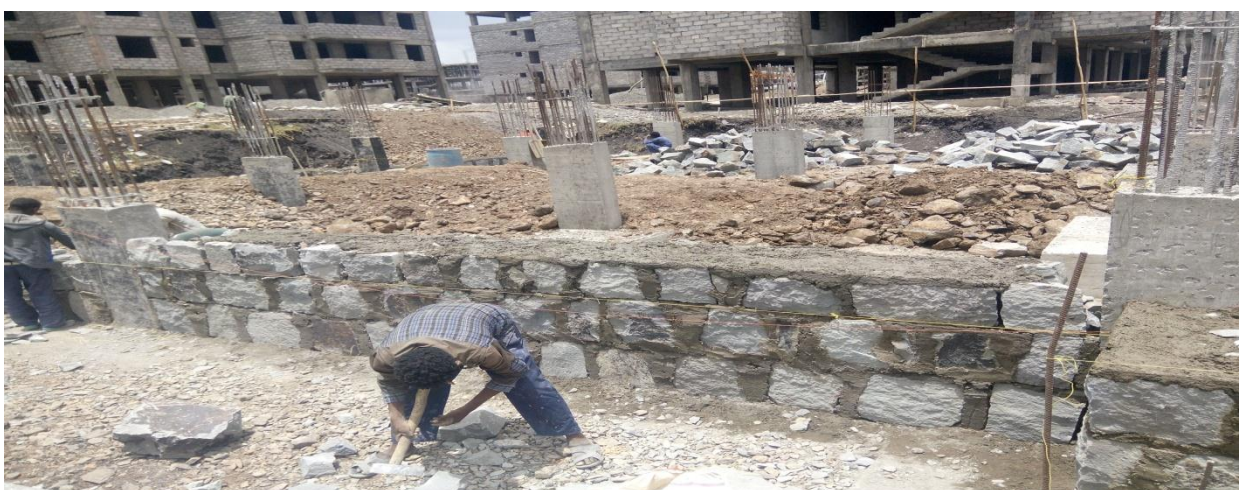
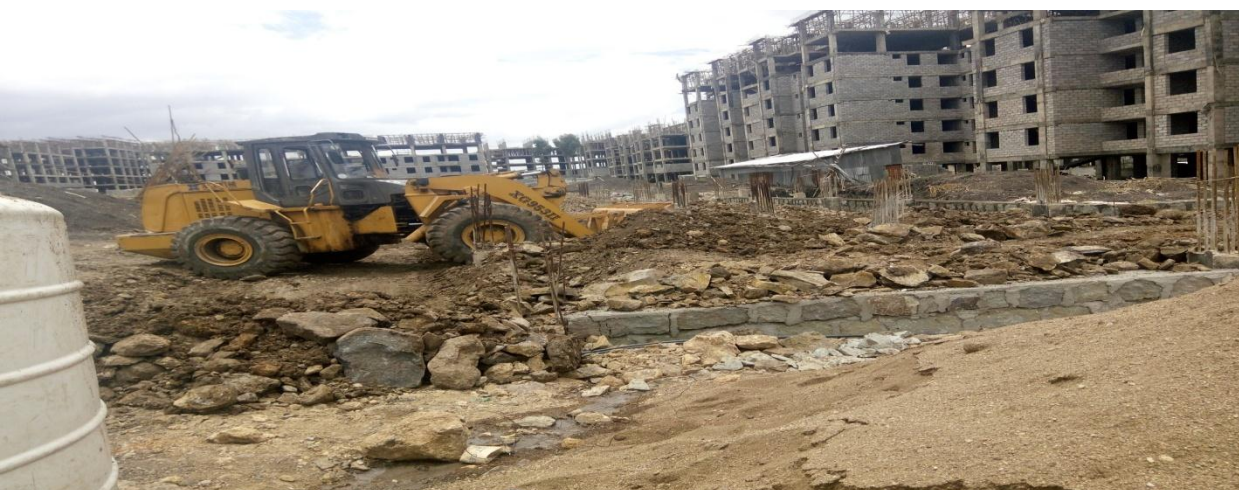
Sample pictures on foundation under construction on the project

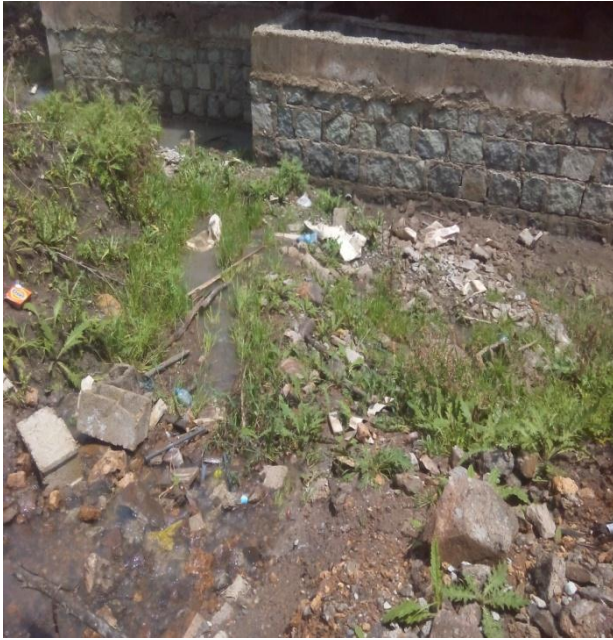
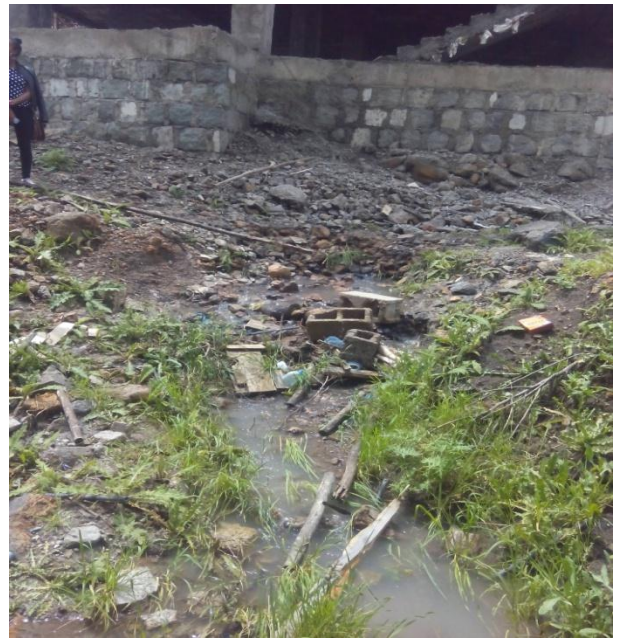
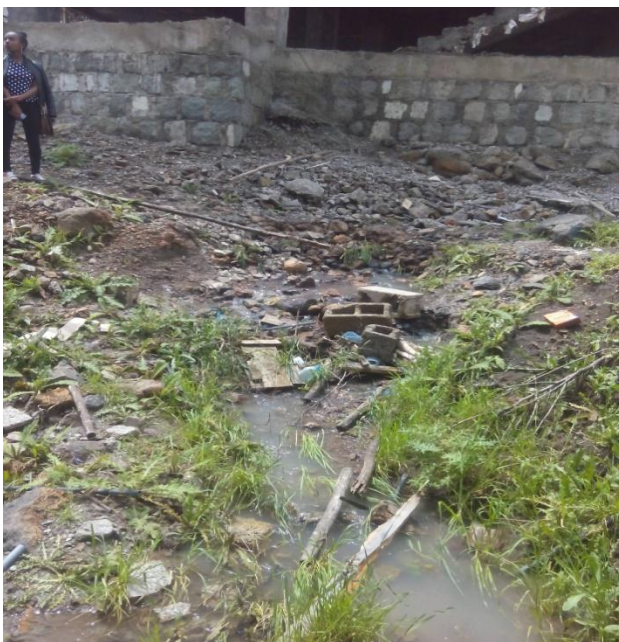
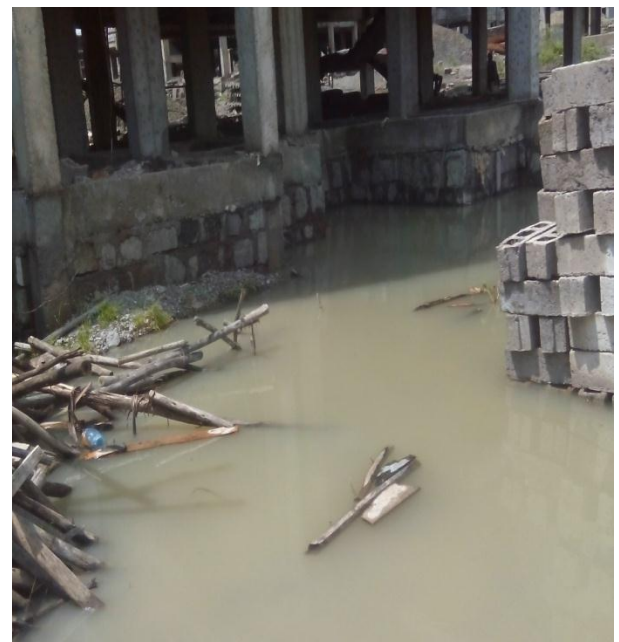
Accumulation and seepage of water under foundation on the project.
